# REPORT NO. 96-14

M7 ARMOR TILE IN A
NONSTANDARD PLYWOOD BOX
UNITED NATIONS (UN)
PERFORMANCE ORIENTED
PACKAGING (POP) AND
MIL-STD-1660 TESTS

# U.S. ARMY DEFENSE AMMUNITION CENTER VALIDATION ENGINEERING DIVISION SAVANNA, IL 61074-9639

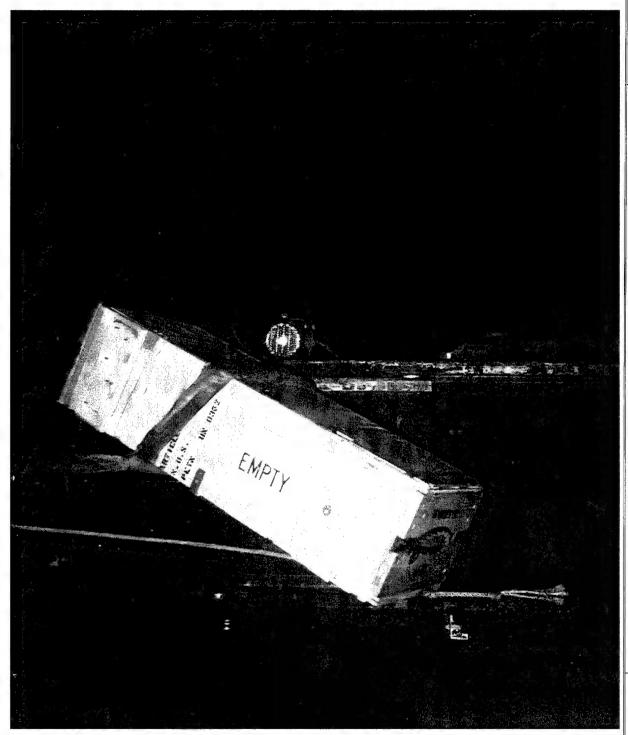
- 1. Plywood box with two bundling wires. During the first test, a plywood box with two bundling wires around the box, perpendicular to the long axis of the box, was dropped at a 45-degree angle onto one corner of the box from a height of 3.9 feet. The box was substantially damaged as a result of the drop test. One of the sides of the box shifted enough to create a gap big enough to allow the inert fill to spill from the box and break one of the wooden cleats at the opposite end of the box.

AO317-SPN-96-089-1126. This photograph shows the armor tile box with two bundling wires raised to 3.9 feet for the 45-degree angle drop required for UN POP certification.

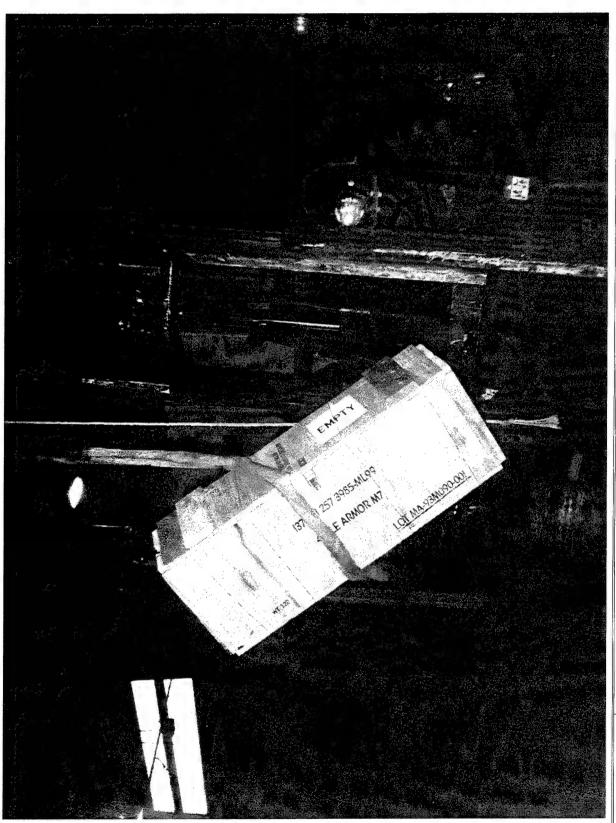
- 2. Plywood box with four bundling wires. During the second test, a plywood box with four bundling wires around the box, perpendicular to the long axis of the box, was dropped at a 45-degree angle onto one corner of the box from a height of 3.9 feet. This box was damaged in a similar fashion as the container that was dropped during the first test.

AO317-SPN-96-089-1122. This photograph shows the armor tile box with four bundling wires raised to 3.9 feet for the 45-degree angle drop required for UN POP certification.

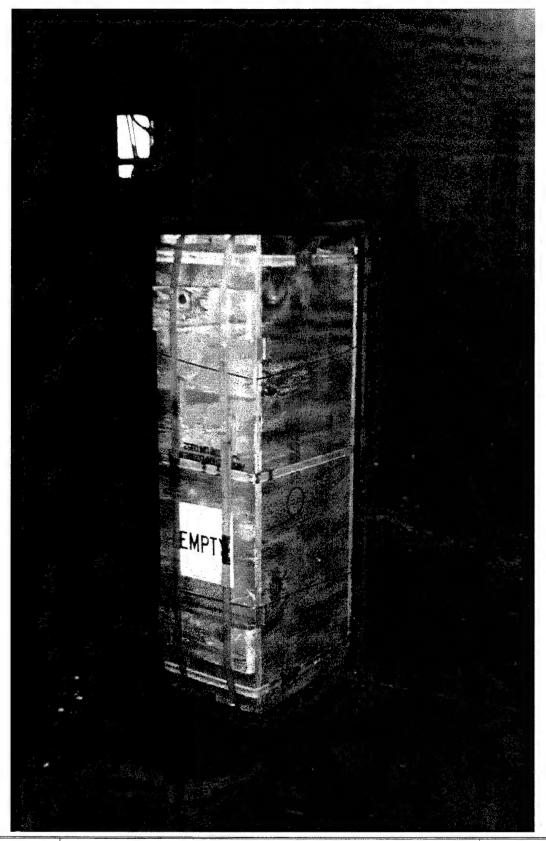
- 4. Plywood box with two bundling wires and five 3/4-inch steel straps. During the fourth and final drop, a box with four bundling wires was modified to include five additional 3/4-inch steel straps. Three straps were added around the box, perpendicular to the long axis of the box, at the middle and approximately 1/2-inch in from either end. The remaining two straps were added lengthwise around the box over the middle of the wooden cleats at either end of the box. This final box was again dropped at a 45-degree angle onto one corner of the box from a height of 3.9 feet. Damage from the drop test consisted of separation of the sides from the ends and separation from the sides with the top and bottom in between the middle and end straps. These gaps were big enough to allow the inert fill to fall from the box.

AO317-SPN-96-089-1130. This photograph shows the armor tile box with five 3/4-inch steel straps after the 3.9-foot, 45-degree angle drop.

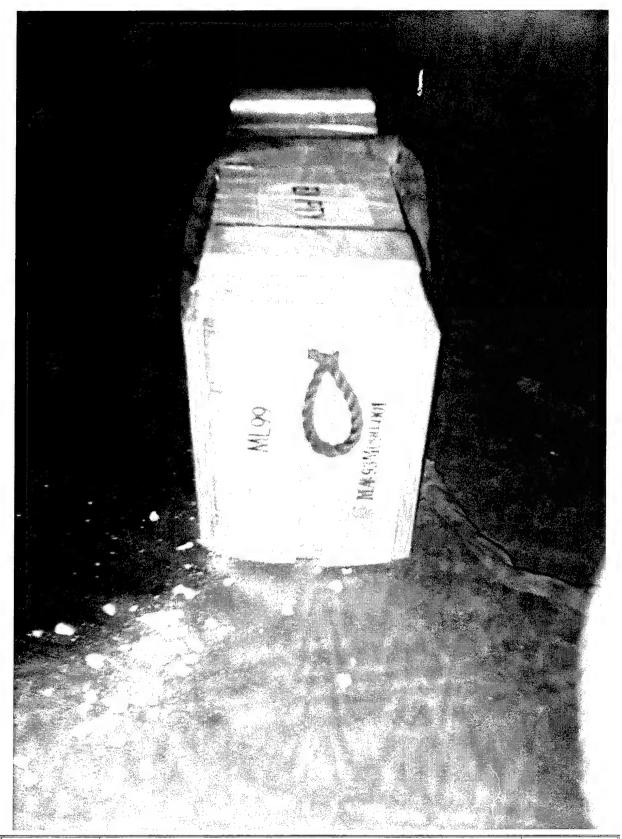
AO317-SPN-96-089-1123. This photograph shows typical damage experienced by the armor tile box during the 3.9-foot, 45-degree angle drop required for UN POP certification.

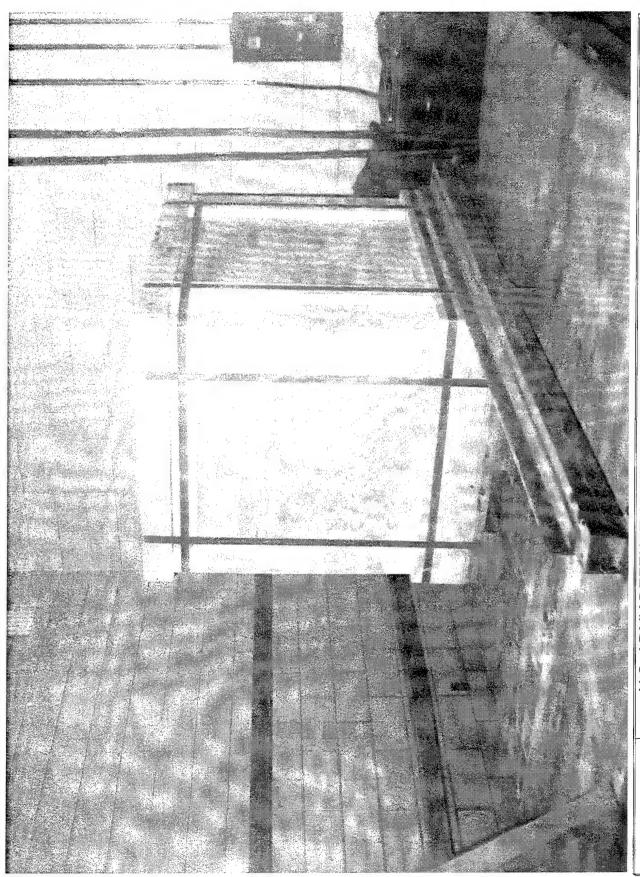
c. Repetitive Shock Test. The test pallet was vibrated 90 minutes at 190 rpm in the longitudinal orientation and 90 minutes at 150 rpm in the lateral orientation. No damage or loosening of the load was noted as a result of this test.

AO317-SPN-96-089-1136. This photograph shows the pallet box on the vibration table in the longitudinal orientation.

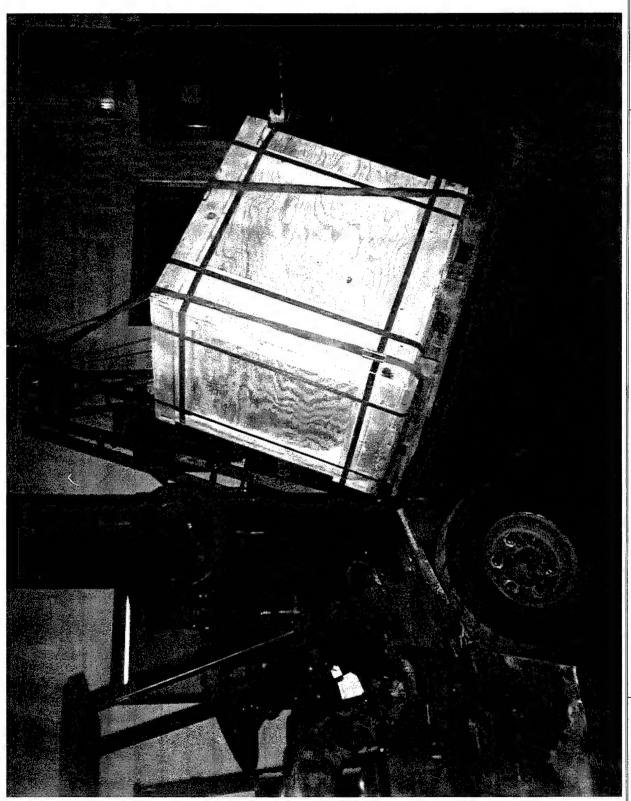
AO317-SPN-96-089-1137. This photograph shows the pallet box on the vibration table in the lateral orientation.

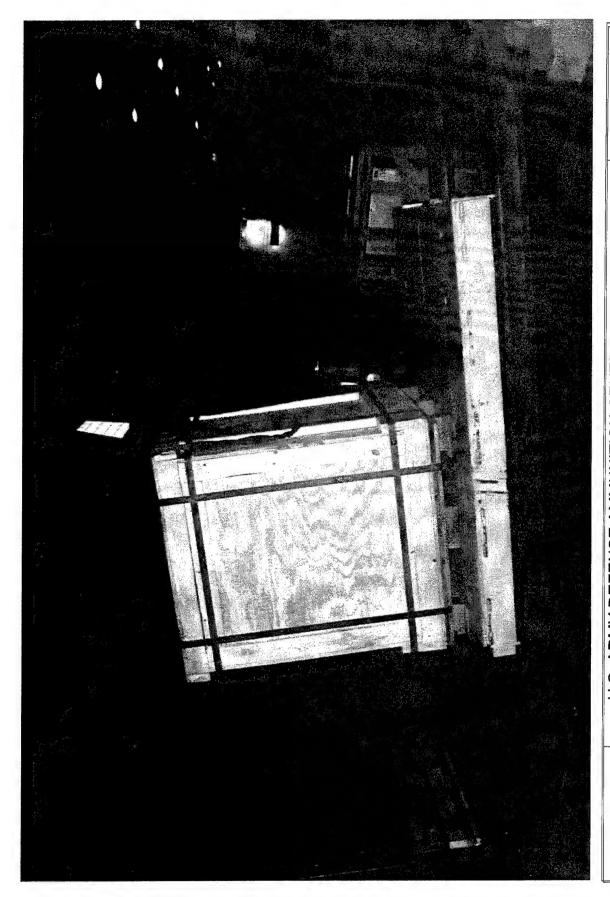
d. Edgewise Rotational Drop Test. The test pallet was edgewise rotationally dropped from a height of 24 inches on the longitudinal drops and 23 inches on the lateral drops (maximum elevation achievable without toppling the pallet). No damage or shifting of the load was noted as a result of this test.

AO317-SPN-96-089-1139. This photograph shows the pallet box raised in preparation for the edgewise rotational drop test.

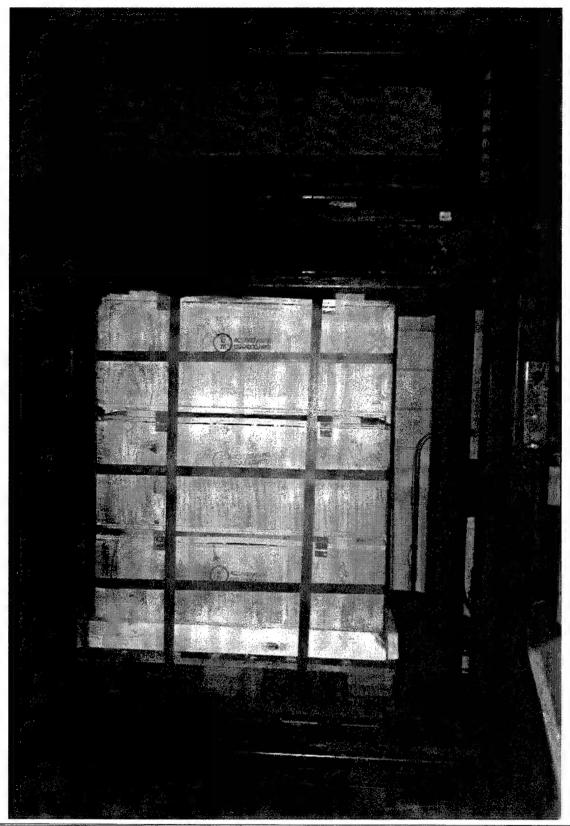
e. <u>Incline-Impact Test</u>. The test pallet was incline-impacted on all four sides from a height of 8 feet. No damage or shifting of the load was noted as a result of this test.

AO317-SPN-96-089-1142. This photograph shows the pallet box on the incline-impact tester.

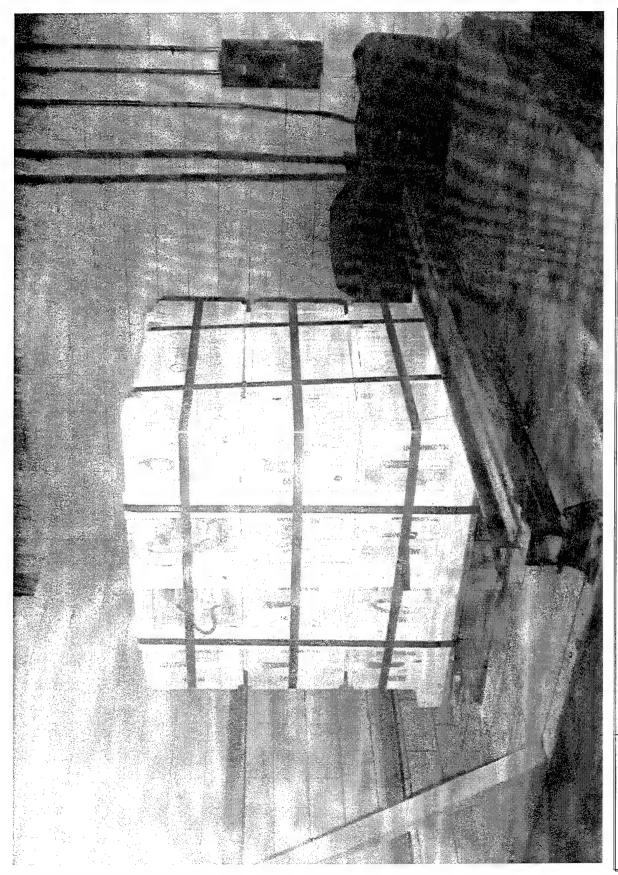
- b. Compression Test. The test pallet was compressed with a load force of 6,680 pounds for a period of 60 minutes. During the compression test, the pallet height was reduced to 49-1/2 inches. No damage was noted as a result of this test.

AO317-SPN-96-089-1150. This photograph shows the armor tile pallet (palletization method no. 1) in the compression tester.

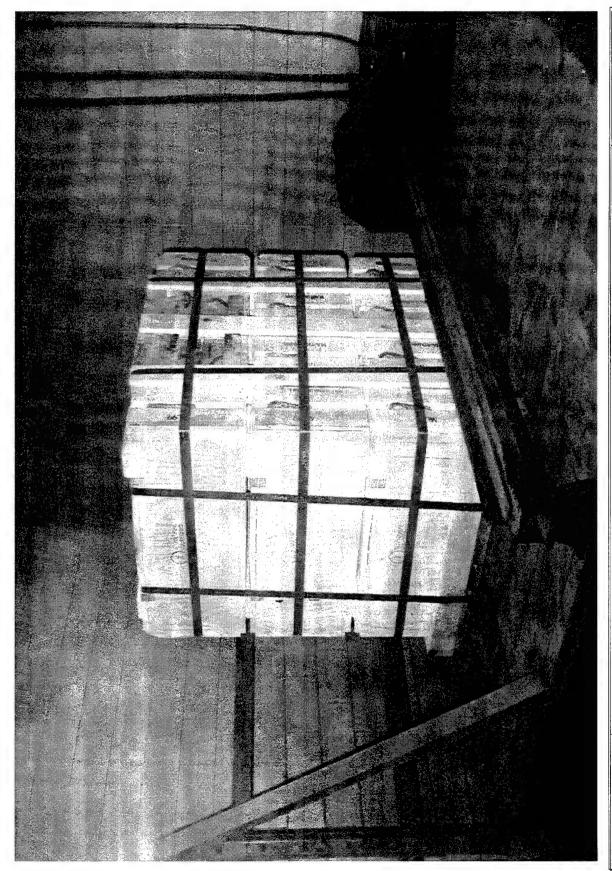
- c. Repetitive Shock Test. The test pallet was vibrated 90 minutes at 170 rpm in the longitudinal orientation and 90 minutes at 190 rpm in the lateral orientation. No damage or loosening of the load was noted as a result of this test.

AO317-SPN-96-089-1151. This photograph shows the armor tile pallet (palletization method no. 1) on the vibration table in the longitudinal orientation.

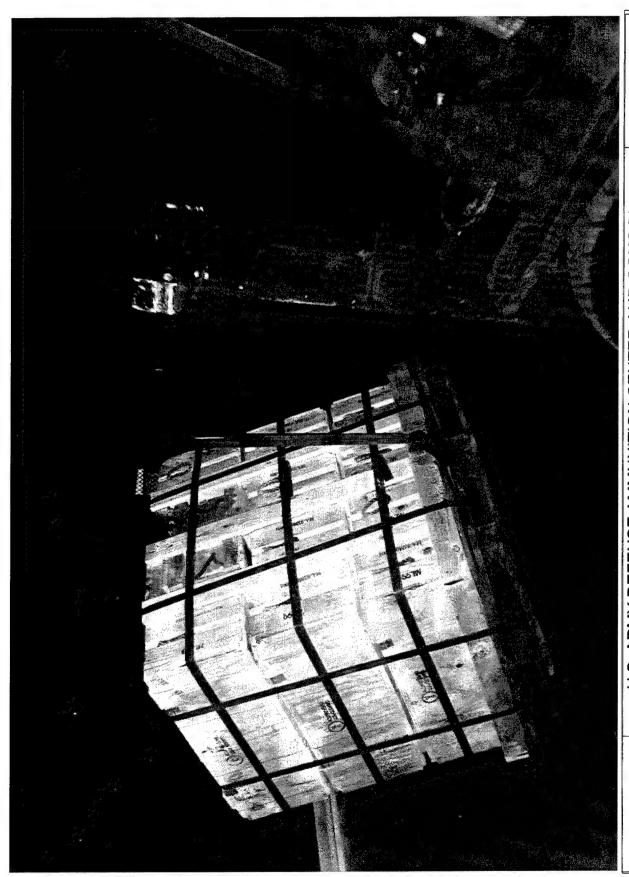
AO317-SPN-96-089-1152. This photograph shows the armor tile pallet (palletization method no. 1) on the vibration table in the lateral orientation.

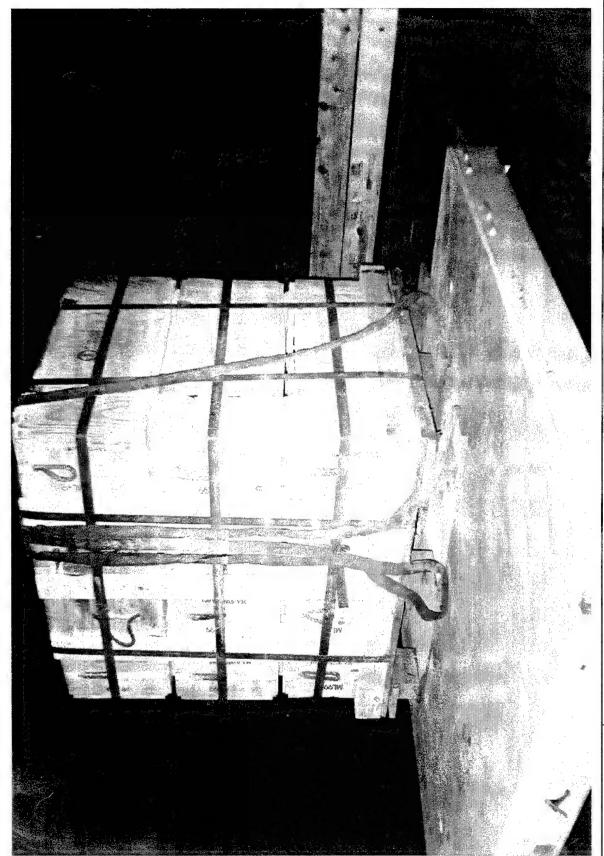
- d. Edgewise Rotational Drop Test. The test pallet was edgewise rotationally dropped from a height of 24 inches on the longitudinal drops and 23 inches on the lateral drops (maximum elevation achievable without toppling the pallet). No damage or shifting of the load was noted as a result of this test.

AO317-SPN-96-089-1156. This photograph shows the armor tile pallet (palletization method no. 1) raised in preparation for the edgewise rotational drop test.

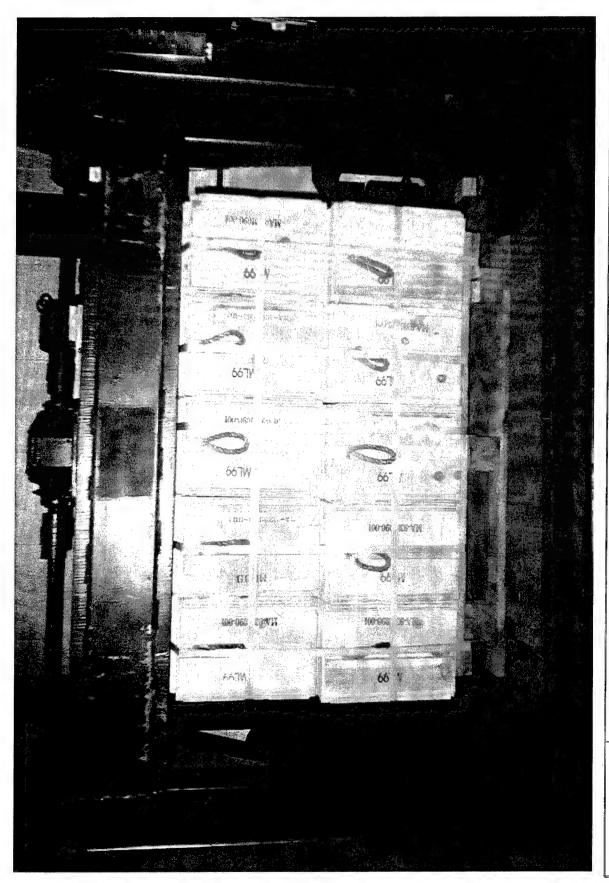
- e. <u>Incline-Impact Test</u>. The test pallet was incline-impacted on all four sides from a height of 8 feet. No damage and only minor shifting of the load was noted as a result of this test.

AO317-SPN-96-089-1160. This photograph shows the armor tile pallet (palletization method no. 1) on the incline-impact tester.

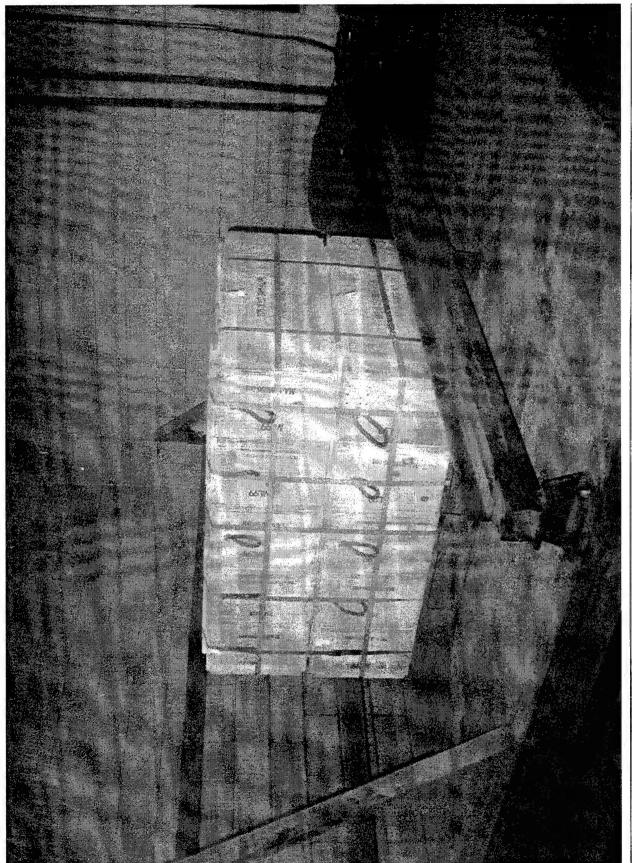
- b. <u>Compression Test</u>. The test pallet was compressed with a load force of 7,460 pounds for a period of 60 minutes. During the compression test, the pallet height was reduced to 34-3/4 inches. No damage was noted as a result of this test.

AO317-SPN-96-089-1140. This photograph shows the armor tile pallet (palletization method no. 2) in the compression tester.

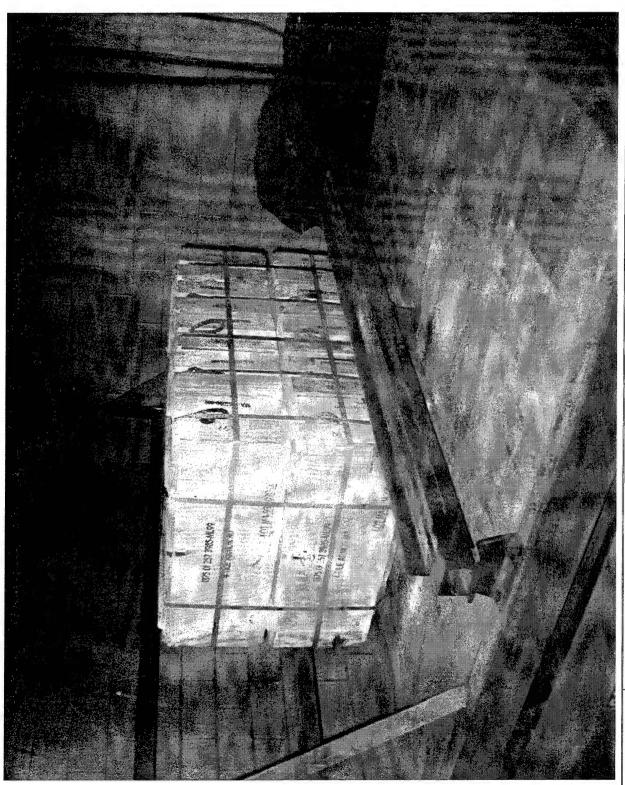
- c. Repetitive Shock Test. The test pallet was vibrated 90 minutes at 220 rpm in the longitudinal orientation and 90 minutes at 195 rpm in the lateral orientation. No damage or loosening of the load was noted as a result of this test.

AO317-SPN-96-089-1141. This photograph shows the armor tile pallet (palletization method no. 2) on the vibration table in the longitudinal orientation.

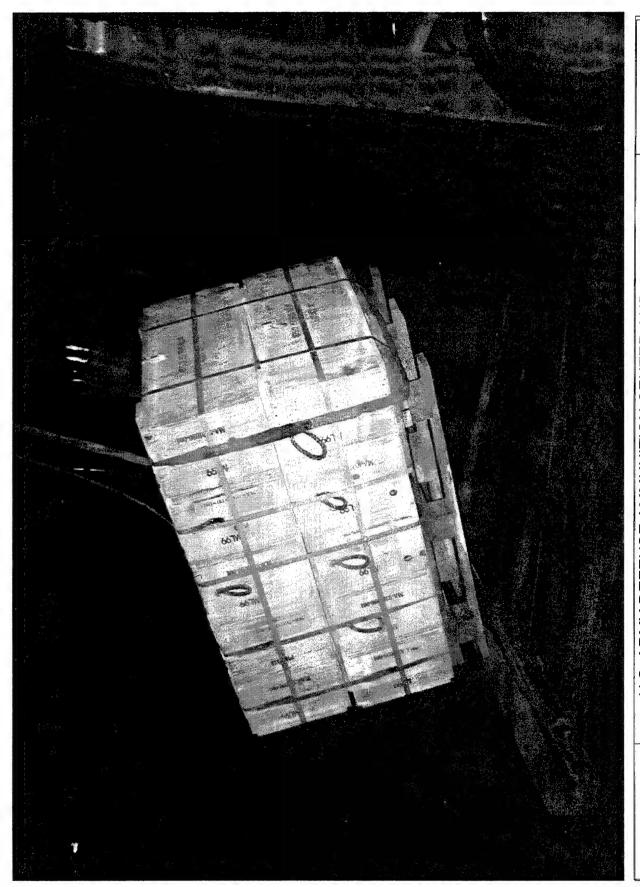
AO317-SPN-96-089-1142. This photograph shows the armor tile pallet (palletization method no. 2) on the vibration table in the lateral orientation.

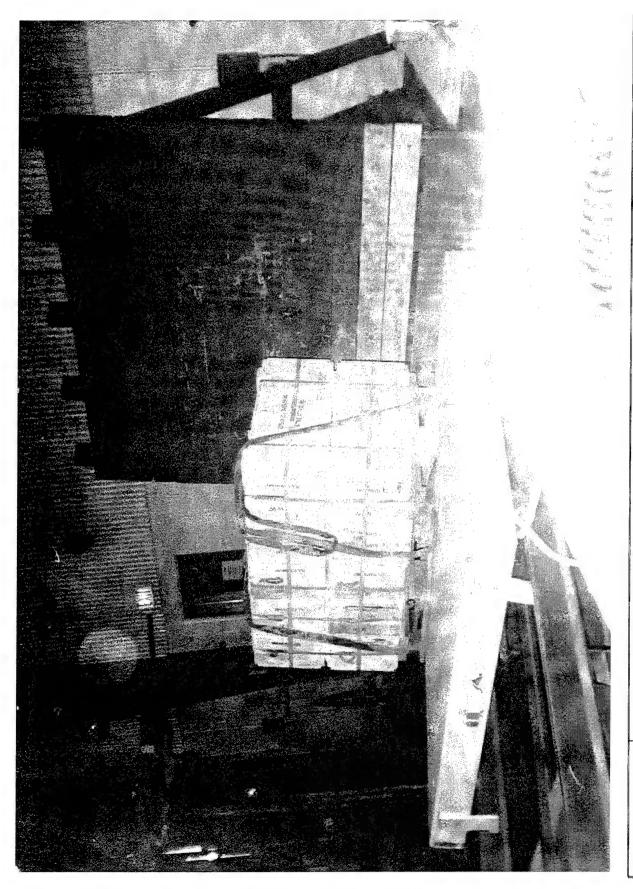
- d. Edgewise Rotational Drop Test. The test pallet was edgewise rotationally dropped from a height of 24 inches on all four sides. No damage or shifting of the load was noted as a result of this test.

AO317-SPN-96-089-1143. This photograph shows the armor tile pallet (palletization method no. 2) raised in preparation for the edgewise rotational drop test.
